LOWER CLEAR CREEK FLOODWAY REHABILITATION PROJECT 2A FLOODPLAIN CONSTRUCTION AND REVEGETATION PROGRESS REPORT

September 2001

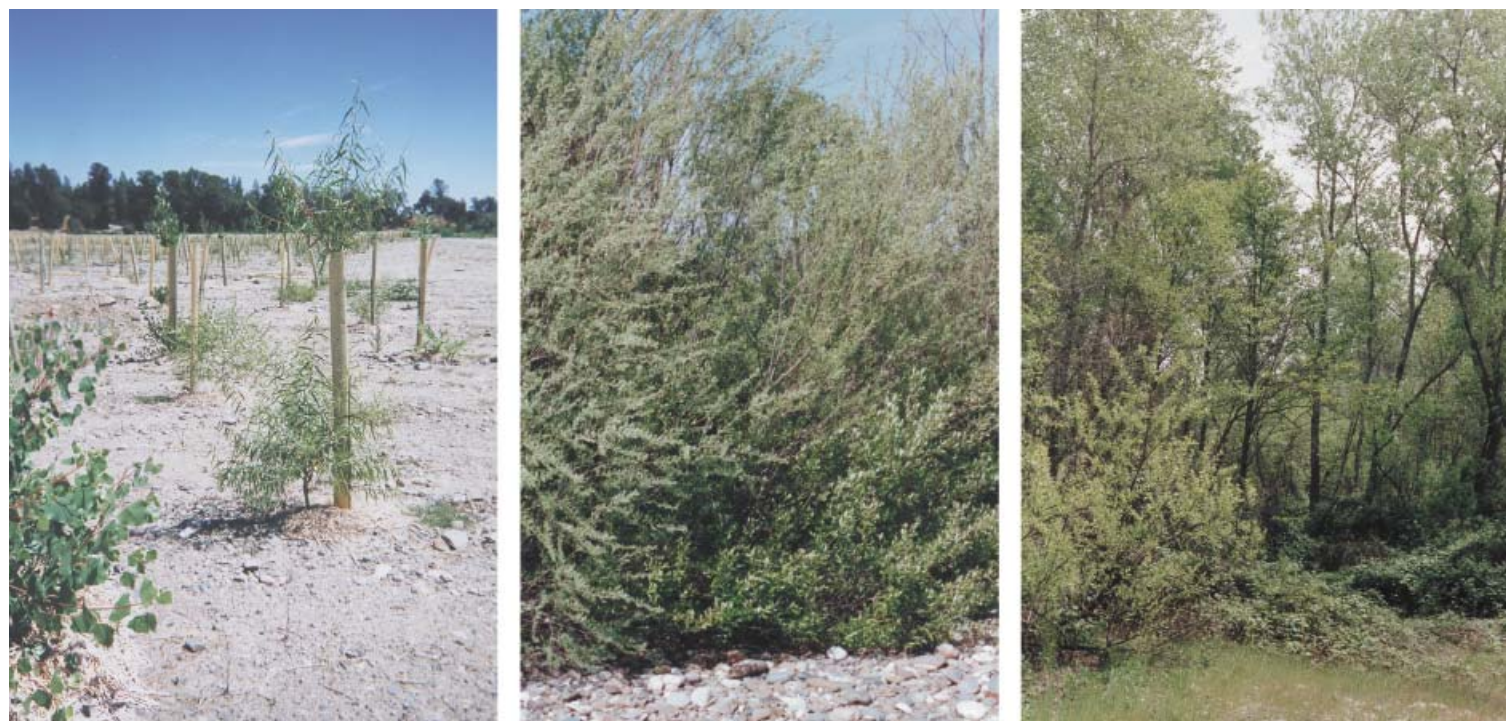
Chronology towards desired future conditions. Starting on the left, planted cuttings in their first year at Restoration Grove. The center photograph shows a maturing patch of willows (foreground) and cottonwood (background) adjacent to exposed cobble/gravel bar surface. Scour channels of varying depth and cover provide seasonal habitat for amphibians, mammals, birds, and salmonids. The right photo shows mature cottonwoods reaching senescence, which will provide habitat for raptors, cavity nesting birds and mammals, and if channel migration occurs, large woody debris to the stream. As we continue to implement, monitor, observe, and learn, each new phase of the Lower Clear Creek Floodway Rehabilitation Project will improve, providing valuable information for other restoration efforts on alluvial river ecosystems.

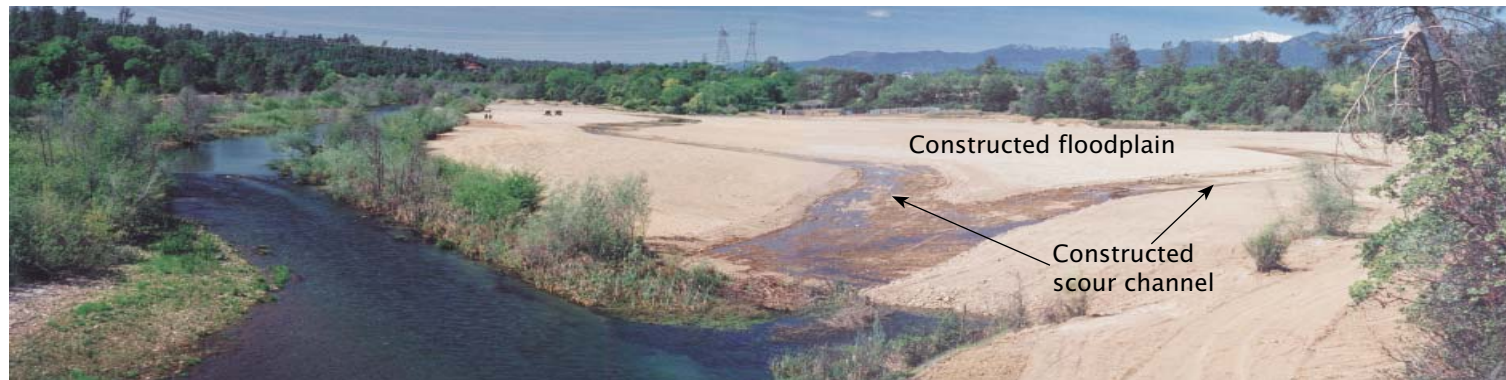
Panorama of Restoration Grove after construction was completed. The scour channel is saturated by groundwater soon after design completion.

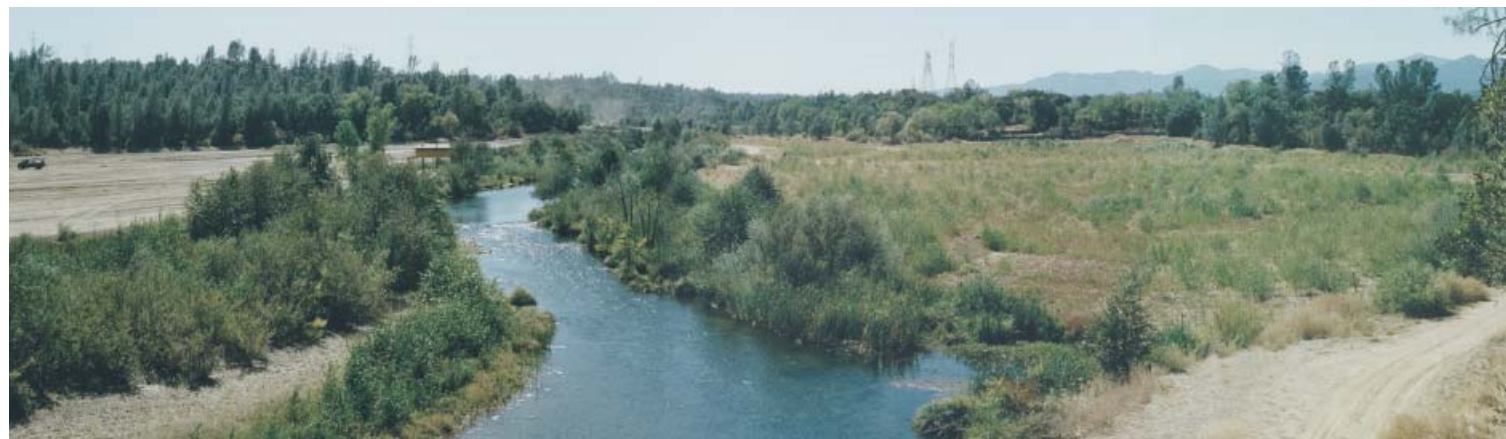
Panorama of Restoration Grove as of September 2001. The initial planting of Fremont cottonwood and mixed willow series is in its second year, and the natural revegetation of the scour channel with hardwoods and sedges can be seen in the photograph.

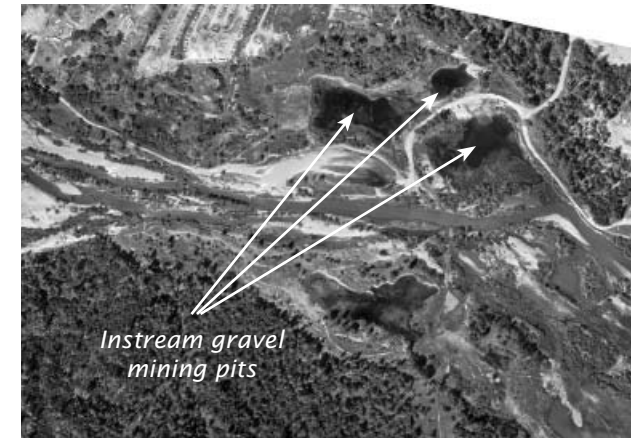
Aerial photograph of Restoration Grove prior to construction 1997 (1" = 950').

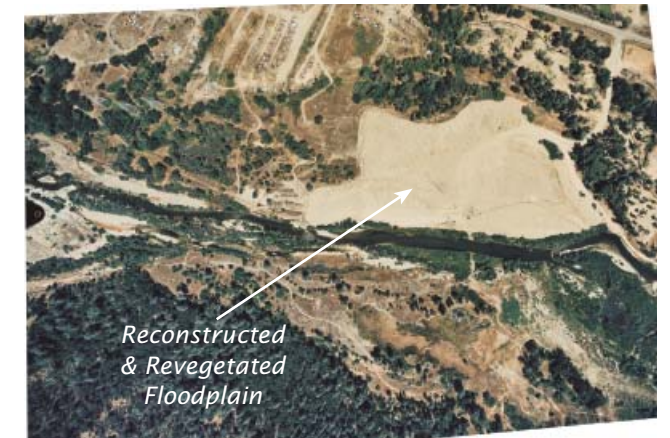
Aerial photograph of Restoration Grove after construction and planting, 2000 (1" = 950').

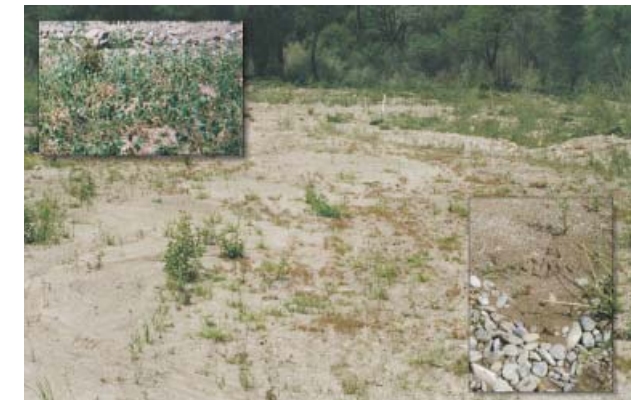
Natural regeneration was also prolific in areas with a high water table and fine sands and silts. The scour channels quickly recruited thousands of Fremont cottonwood seedlings, but few willows. Additionally, natural sedge recruitment occurred over nearly the entire length of the scour channels.

Upper inset - natural cottonwood recruitment on constructed floodplains. Background photo - fine sediment deposits in scour channel at Reading Bar, showing subtle meandering. Lower inset - close-up of fine sand deposition at Reading Bar.
