REVISED GEOLOGIC HAZARDS AND GEOTECHNICAL ENGINEERING REPORT COLLEGE OF THE SISKIYOUS THEATER ARTS RENOVATIONS AND MCCLOUD HALL CANOPY

800 College Avenue Weed, California MPE No. 05040-03 July 26, 2024

Revised Geologic Hazards and Geotechnical Engineering Report COLLEGE OF THE SISKIYOUS THEATER ARTS RENOVATIONS and MCCLOUD HALL CANOPY

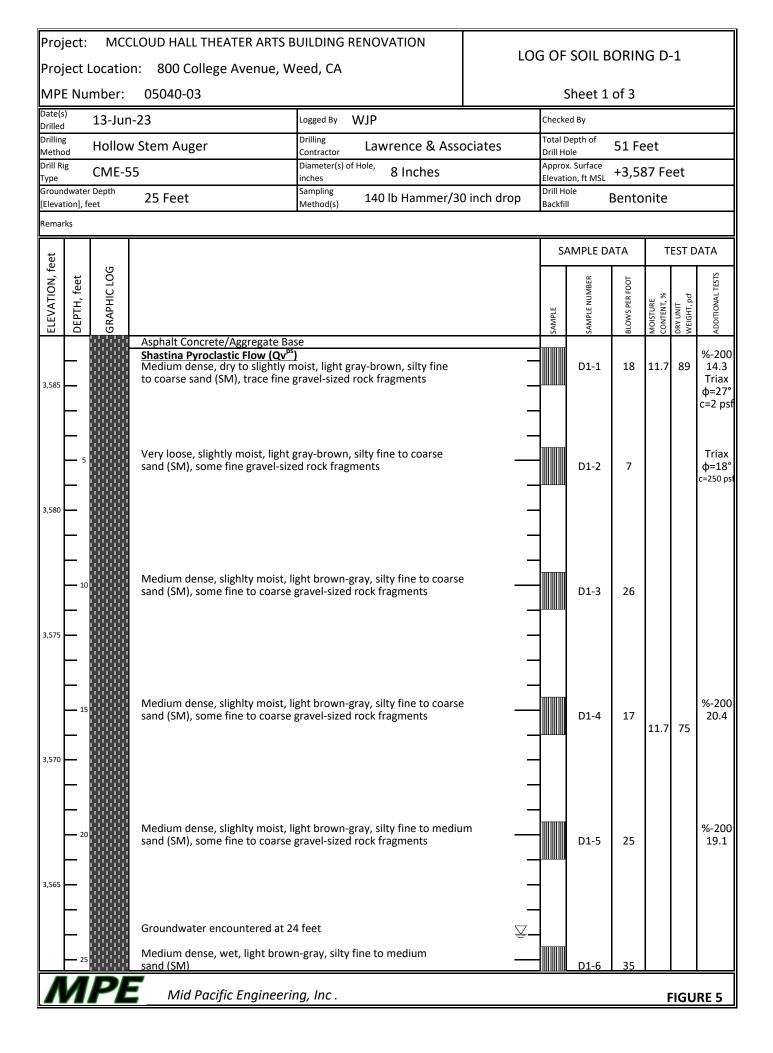
Project: Project Lo		L THEATER ARTS E		NOVATION	LO	G OF	SOIL B	ORIN	IG D	-2			
MPE Number: 05040-03							Sheet 1 of 1						
Date(s) Drilled 13-Jun-23 Logged By WJP							d By						
Drilling	Hollow Stem Aug	ger	Drilling Contractor	Lawrence & Ass	ociates	Total D Drill Ho	epth of	21 Fe	eet				
Drill Rig	CME-55	<u> </u>	Diameter(s) of H	^{lole,} 8 Inches		Approx	. Surface	+3,5	79 Fe	et			
Type Groundwater D	· ///% FOG	<u>م</u>	inches Sampling	140 lb Hammer/3	0 inch drop	Drill Ho		Bento					
[Elevation], fee Remarks	et		Method(s)		F	Backfill							
et						SA	MPLE D	ATA	Т	EST D	ATA		
ELEVATION, feet DEPTH, feet	GRAPHIC LOG	ENGINEERING CL4	ASSIFICATIO	N AND DESCRIPT	TION	SAMPLE	SAMPLE NUMBER	BLOWS PER FOOT	MOISTURE CONTENT, %	DRY UNIT WEIGHT, pcf	ADDITIONAL TESTS

-	Shastina P Loose to m	P yroclastic Flow (Qv^{p:} nedium dense, slightl n sand. Roots to ½-ind	y moist, light g	gray-brown, silty fine	·			а	2.0		/		
3,575					_		D2-1	14			Triax φ=27 c= 2ps		
5 		nedium dense, slightl dium sand, some fine					D2-2	14	6.6	83			
3,570 10	Medium d coarse san	ense, slightly moist, l nd (SM), some fine to	ight brown-gra coarse gravel-	ay, silty fine to sized rock fragment:	s		D2-3	26	9.1	96			
3,565 — 15 — 15		ense, slightly moist, l nd (SM), some fine to					D2-4	21					
3,560 — 20	(SM), scatt	ense, wet, light brow tered fine to coarse g iter encountered at 2	gravel-sized roo		¥		D2-5	34					
3,555 25		Groundwater	l Depth = 21 Fo Encountered lled with Bento	at 20½ Feet									
M	PE Mid	Pacific Engineeri	na. Inc					<u>I</u>	·		RE 6

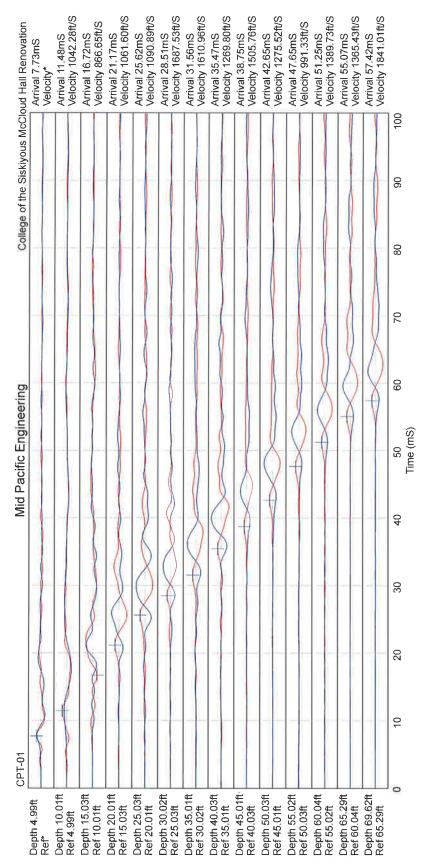
Hammer to Rod String Distance (ft): 5.83 * = Not Determined

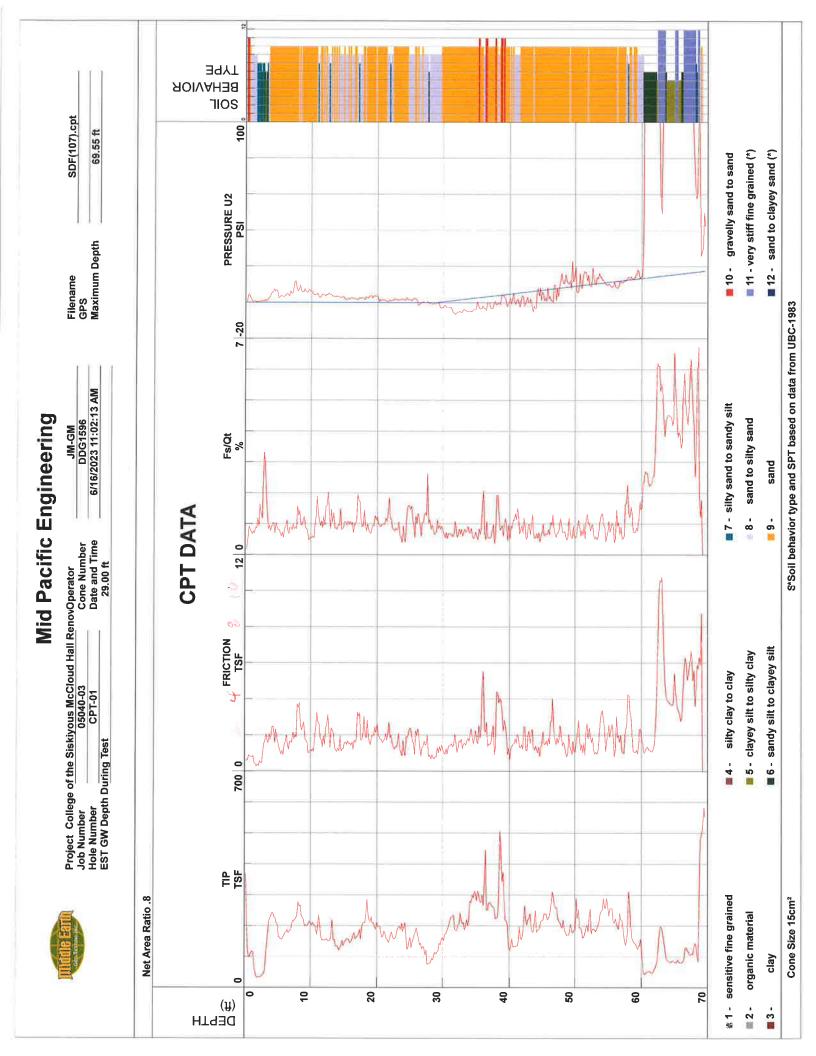
Project ID: Mid Pacific Engineering Data File: SDF(100).cpt CPT Date: 6/16/2023 12:22:51 PM GW During Test: 29 ft

GW Durin	ig res	t: 29	ft																Cone	/Rig:	DDG15	96
Depth ft	qc PS tsf	qcln PS -	qincs PS	* qt PS tsf	Stss	pore prss (psi)	Frct Rato		Behavior	Uni Wgh pc	t to		SPT R-N 60	SPT ICN1 60		* Ftn Ang deg	Und Shr tsf	OCR - -	+ Fin Ic	* 	/ SBT Indx	/ Nk ~
$\begin{array}{c} 0.33\\ 0.49\\ 0.682\\ 0.98\\ 1.15\\ 1.31\\ 1.48\\ 1.80\\ 1.97\\ 2.13\\ 2.46\\ 2.69\\ 2.95\\ 3.28\\ 3.45\\ 3.61\\ 3.77\\ 3.94\\ 4.10\\ 4.27\\ 4.10\\ 4.27\\ 4.10\\ 4.27\\ 3.94\\ 4.10\\ 4.27\\ 3.94\\ 5.55\\ 5.41\\ 5.56\\ 1.6\\ 5.74\\ 5.99\\ 5.25\\ 5.41\\ 5.56\\ 7.12\\ 7.38\\ 6.66\\ 6.73\\ 6.23\\ 6.66\\ 6.73\\ 7.55\\ 7.71\\ 7.87\\ 8.20\\ 6.53\\ 8.69\\ 8.53\\ 8.69\\ 8.53\\ 8.69\\ 9.02\\ 9.19\\ 9.35\\ 9.66\\ 9.02\\ 9.59\\ 9.51\\ 9.56\\$	14, 3 14, 3 24, 6 69, 8 57, 8 55, 2 57, 8 50, 2 57, 8 50, 2 57, 8 38, 8 38, 8 36, 1 33, 8 226, 0 27, 3 38, 8 35, 1 33, 8 226, 0 27, 3 38, 8 43, 5 57, 4 45, 5 57, 4 41, 4 55, 7 45, 5 57, 4 41, 4 45, 5 57, 4 41, 4 55, 7 41, 4	52.3 111.9 120.6 92.6 80.5 76.3 86.5 77.6 80.5 77.6 80.5 77.9 50.2	$\begin{array}{l} 115. 4\\ 115. 5\\ 1124. 9\\ 1124. 9\\ 126. 4\\ 1125. 6\\ 1124. 9\\ 126. 4\\ 1125. 6\\ 1124. 9\\ 126. 4\\ 1125. 6\\ 1128. 6\\ 90. 8\\ 990. 8\\ 990. 8\\ 990. 8\\ 990. 8\\ 990. 8\\ 990. 8\\ 128. 6\\ 8990. 8\\ 990. 8\\ 128. 6\\ 8990. 8\\ 128. 6\\ 128. 6\\ 134. 6\\ 134. 6\\ 134. 6\\ 134. 6\\ 134. 6\\ 134. 6\\ 135. 6\\ 134. 6\\ 135. 6\\ 134. 6\\ 134. 6\\ 135. 6\\ 134. 6\\ 135. 6\\ 134. 6\\ 135. 6\\ 134. 6\\ 135. 6\\ 135. 6\\ 134. 6\\ 135. 6$	14.3 14.3 14.3 22.6 69.8 57.8 50.2 53.9 33.8 65.5 53.9 33.8 67.5 33.8 67.1 33.8 67.1 33.8 67.1 33.8 67.1 33.8 67.1 33.8 67.1 33.8 67.1 33.8 67.1 41.4 67.1 59.6 55.7 4 41.4 67.1 13.9 67.1 13.9 67.8 72.4 135.9 80.8 80	$\begin{array}{c} 0.66\\ 0.78\\ 0.78\\ 0.9\\ 0.9\\ 0.9\\ 0.9\\ 0.9\\ 0.9\\ 0.9\\ 0.9$	$\begin{array}{c} 0&2&3&3\\ 0&3&4&6&6\\ 0&5&5&6&6&6&6&6&6&6&6&6&6&6&6&6&6&6&6&6&$	$\begin{array}{c} 3.50\\ 3.204\\ 0.90\\ 1.44\\ 1.23\\ 1.78\\ 1.41\\ 1.23\\ 1.78\\ 1.41\\ 1.23\\ 1.78\\ 1.41\\ 1.23\\ 1.78\\ 1.41\\ 1.23\\ 1.21\\ 1.00\\ 0.99\\ 1.22\\ 1.21\\ 1.11\\ 1.00\\ 0.90\\ 1.7\\ 1.21\\ 1.21\\ 1.00\\ 0.90\\$	***************************************	silty CLAY to CLAY clayy SILT to silty CL clayy SILT to silty CL clay SAND to sinty CL clean SAND to silty SA clean SAND to sinty SA clean SAND to sandy SI silty SAND to sandy SI clean SAND to silty SA clean SAND to silty SA clea	11 AY 11 AY 11 IX 11 IX 11 IX 11 IX 11 IX 11 IX 12 IT 12 IT 12 LT 12 ND 12 ND <th12< th=""></th12<>	$ \begin{array}{cccccccccccccccccccccccccccccccccccc$	$ \begin{array}{c} & & & & & & & \\ & & & & & & \\ & & & & $	$\begin{array}{c} 100\\ 100\\ 9\\ 122\\ 111\\ 144\\ 155\\ 122\\ 121\\ 121\\ 122\\ 122\\ 122\\ 121\\ 100\\ 9\\ 9\\ 9\\ 100\\ 122\\ 122\\ 121\\ 121\\ 122\\ 122\\ 121\\ 122\\ 122\\ 121\\ 122\\ 12$	$\begin{array}{c} 7\\ 8\\ 8\\ 100\\ 1222\\ 222\\ 11\\ 17\\ 17\\ 17\\ 17\\ 17\\ 17\\ 17\\ 17\\ 17$	47134608221984728343448812213333469200166029338612255555555555555555555555555555555555	g - 4488888886665544333333333333333333333333		9.9 9.9	479325991180160181518120020176241131207897655555555555555555555555555555555555	num 0.0050 0.0700 0.2000 0.350	$\begin{array}{c}\\ 2.67\\ 2.53\\ 1.86\\ 2.10\\ 2.11\\ 1.84\\ 2.12\\ 2.12\\ 2.17\\ 2.15\\ 2.22\\ 2.12\\ 2.17\\ 2.15\\ 2.22$	$\frac{1}{1} + \frac{1}{1} + \frac{1}$

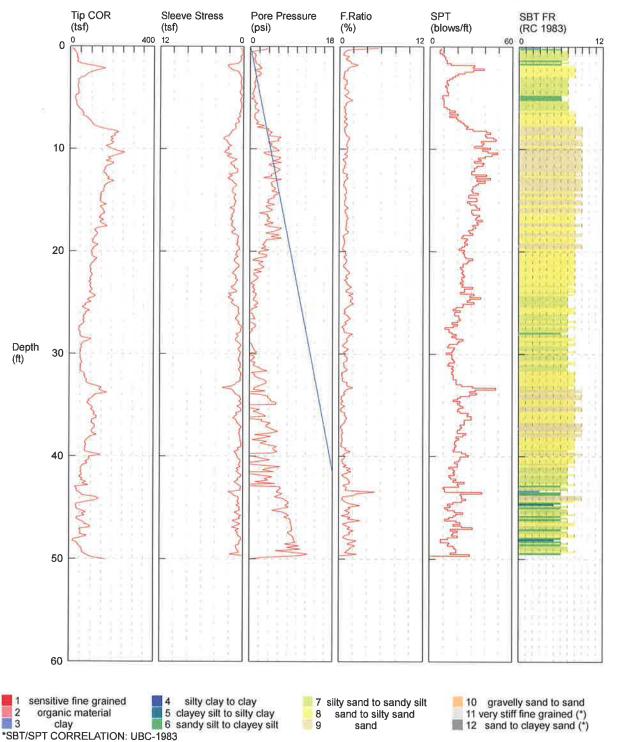
SOUNDING

SOUNDING CUSTOMER: Taber Drilling OPERATOR: David CONE ID: DDG1570 LOCATION: JOB NUMBER: HOLE NUMBER: CPT-1 TEST DATE: 6/18/2024 9:01:12 AM COMMENT: Auto Enhance On COMMENT: Filter On

COMMENT: GPS (LAT,LON,ALT): 0.00,0.00,0.0 LOCATION: LOCATION: LOCATION:

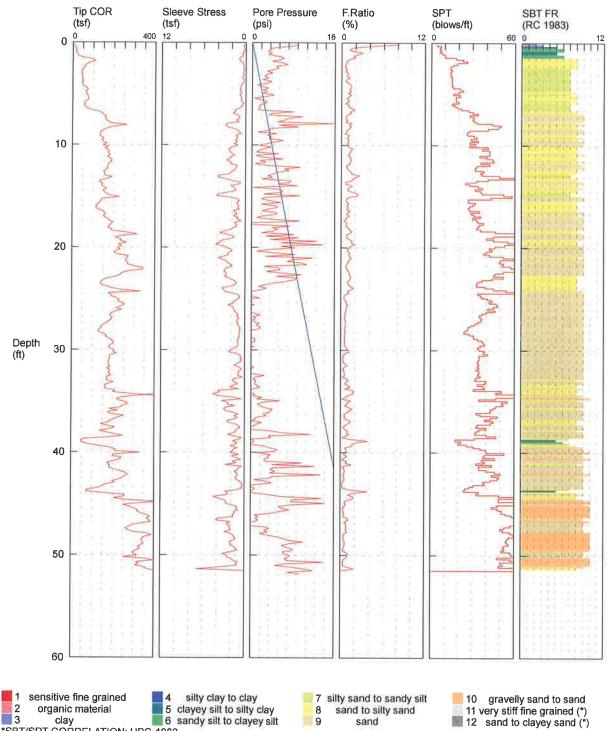
SOUNDING

SOUNDING CUSTOMER: Taber Drilling OPERATOR: David CONE ID: DDG1570 LOCATION:

JOB NUMBER: HOLE NUMBER: CPT-2 TEST DATE: 6/18/2024 10:57:37 AM COMMENT: Auto Enhance On COMMENT: Filter On

COMMENT: GPS (LAT,LON,ALT): 0.00,0.00,0.0 LOCATION: LOCATION: LOCATION:
